Project Case Study

Leapale Road Car Park

Multi-Storey Car Park

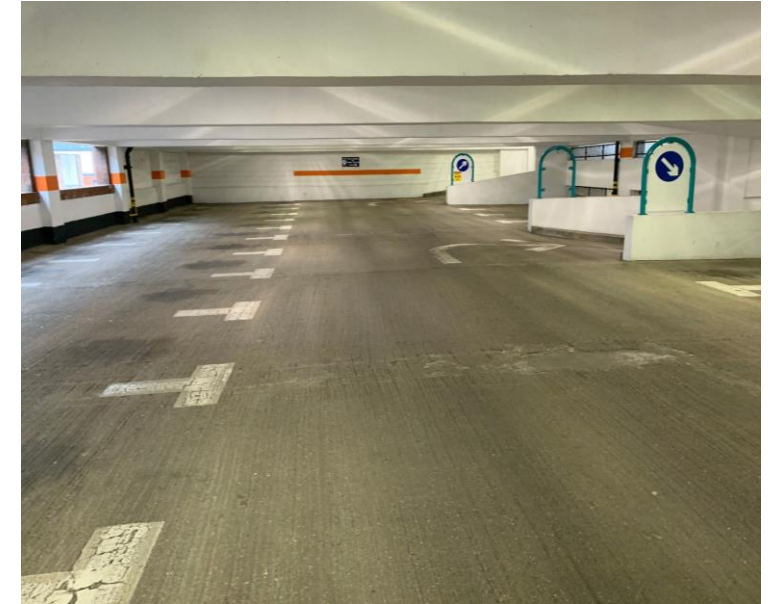
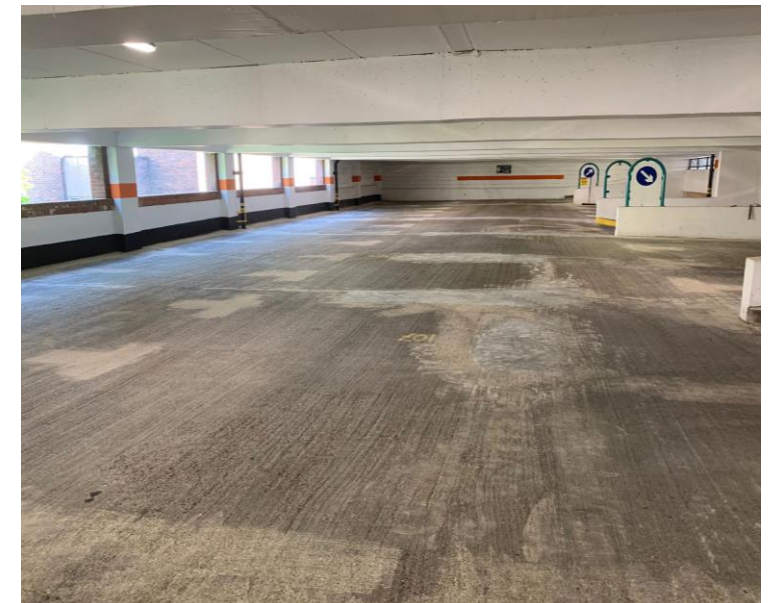
The internal parking decks were mostly uncoated, and consisted of a brushed concrete finish with thermoplastic line markings, to provide parking bay delineation. The semi-exposed areas on Level 3 had deck coatings applied, and both the exposed top decks and ramps also had an existing waterproof coating installed, however this was worn and delaminating in several locations, with staining visible on level 9 & 10's soffits.

StructureCare's scope of works involved re-surfacing all car park decks, and applying high quality, easy to clean and durable protective deck coatings, to improve the aesthetics within the car park. This also prevented further water and salt ingress into the concrete structure.

Furthermore, concrete repairs were also undertaken to all levels of the structure, using high build, lightweight, fibre-reinforced and cementitious repair materials. In addition, PatchGuard 350 anodes were installed around the perimeter of all repaired concrete areas. This was to prevent the incipient anode formation in adjacent chloride-contaminated concrete. In terms of concrete repairs, 849.00m² of repairs were undertaken throughout the MSCP. IN total 9,500m² of Deck coatings were applied to all levels of the car park.
